Manhole Inspection Summary

Manhole # S11CC_010MH

Insp Date: **2/25/08 1:22 PM**

Location Address: **3001 LYTTLETON RD**

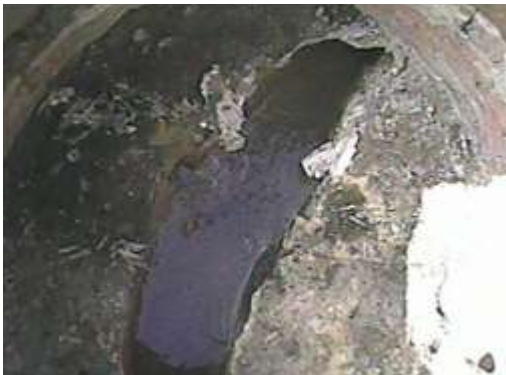
Defect 1

Condition: ☐ Sound ☒ **Cracked** ☐ Root Intrusion ☐ Deteriorated ☒ **Leaks** ☐ Debris

CHANNEL LEAKS AND CRACKED

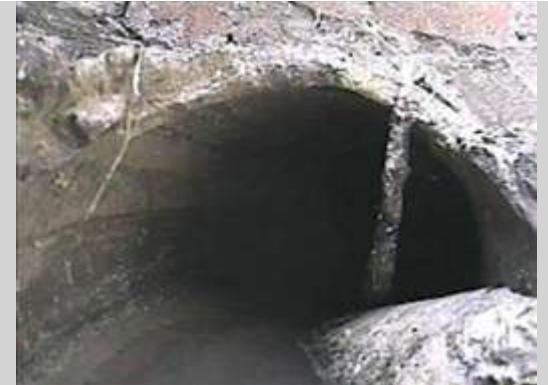
12 O'Clock Outflow

8 in. Circular Gravity Sewer
Pipe Out @ 12 O'Clock

Pipe Height: (in.) Direct
Pipe Material: **Clay** ☐ Pipe Lined
Invert Depth: **2.62** (ft.) Flow Characteristics: **Slow**
Deposits: ☐ None ☐ Mud ☐ Sludge ☒ **Debris** ☐ Grease
Silt Depth: **2** (in.) Deposits Extent: **Light**
Infiltration: **None** Pipe Seal Cond: **Sound**

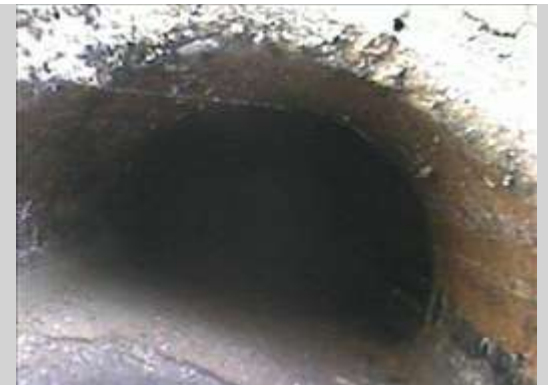
5 O'Clock Inflow

8 in. Circular Gravity Sewer
Pipe In @ 5 O'Clock

Pipe Height: (in.) Direct
Pipe Material: **Clay** ☐ Pipe Lined
Invert Depth: **2.60** (ft.) Flow Characteristics: **Slow**
Deposits: ☐ None ☐ Mud ☐ Sludge ☒ **Debris** ☐ Grease
Silt Depth: **3** (in.) Deposits Extent: **Light**
Infiltration: **None** Pipe Seal Cond: **Sound**
